Study of Inland Wind Effects of Hurricane Fran and Assessment of Inland Wind Model

FEDERAL EMERGENCY MANAGEMENT AGENCY MITIGATION DIVISION

TABLE OF CONTENTS

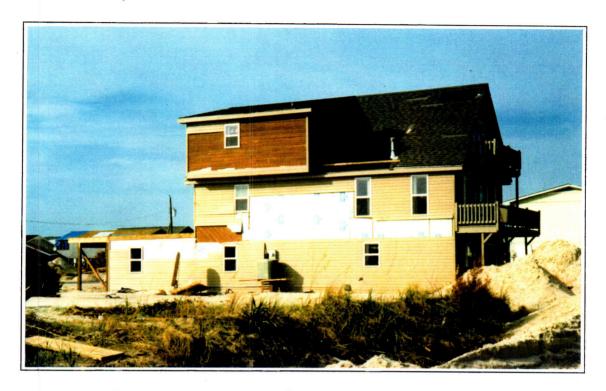
Figure 4-5 Damage to exterior cladding and minor roof damage. (DRG reference: 75- to 95-mph sustained wind speed)

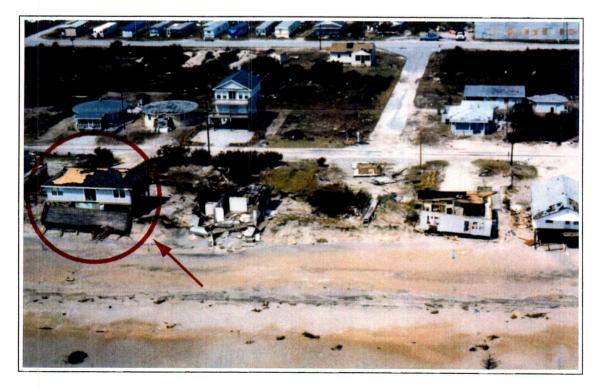
Figure 4-6 Roof shingle damage (arrow). (DRG reference: 75- to 95-mph sustained wind speed)

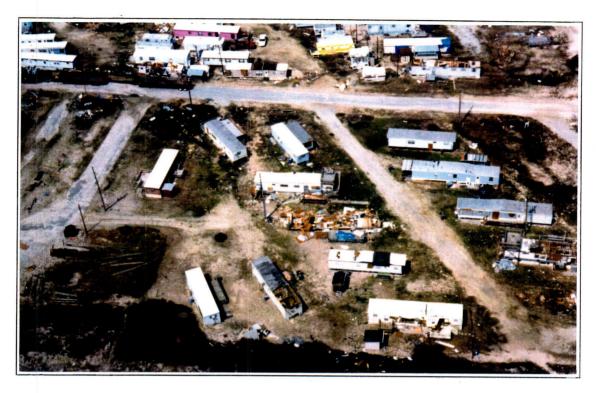
Figure 4-7 Mobile home destroyed. (DRG reference: 75- to 95-mph sustained wind speed)

Significant damage to mobile homes at the coast was sporadic. Aerial photographs of the coastal areas show some instances of major structural damage. Figure 4-7 shows an example of sporadic significant damage. The failures normally occurred to the cladding, roof covering, and the structure. When the frame was adequately anchored to the ground, the foundation of the home remained intact and the home's frame remained upright.

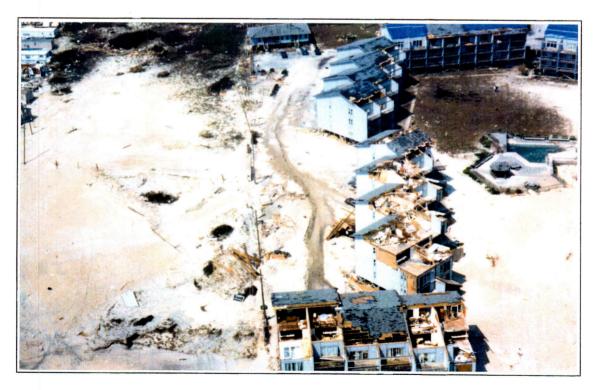
Figure 4-8 Major roof damage. (DRG reference: 96- to 110-mph sustained wind speed)

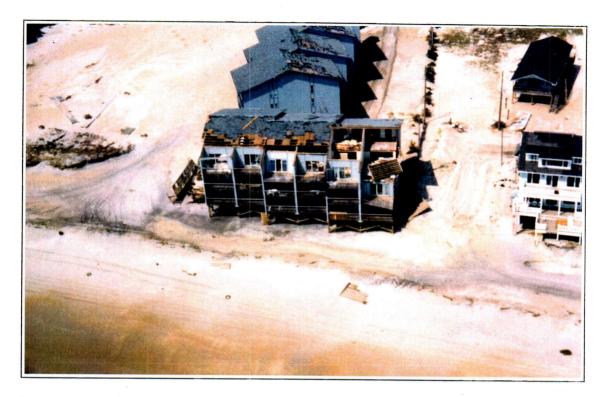
Figure 4-9 Extensive roof damage. (DRG reference: 96- to 110-mph sustained wind speed)

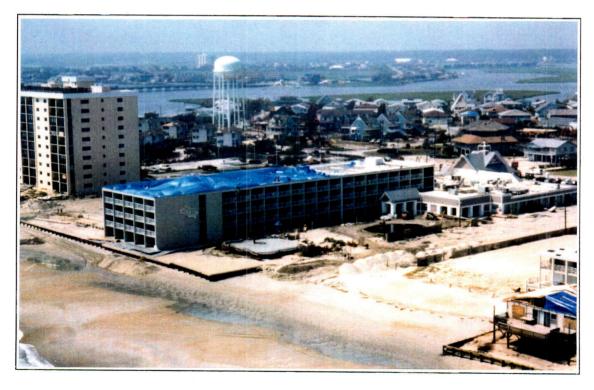
Figure 4-10 Major section of flat roof damaged. (DRG reference: 96- to 110-mph sustained wind speed)

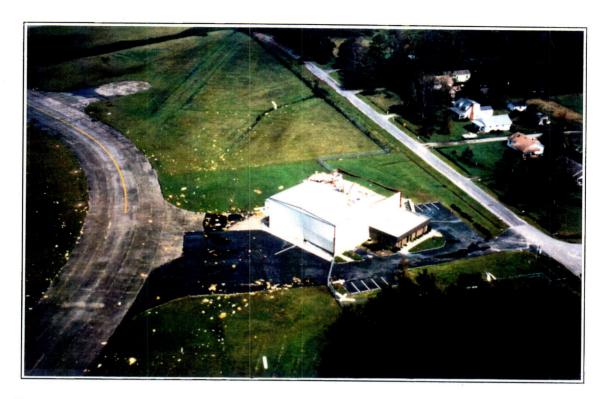
Figure 4-11 Major section of low-sloped roof lost and wall imploded on preengineered metal building. (DRG reference: 75- to 95-mph sustained wind speed)

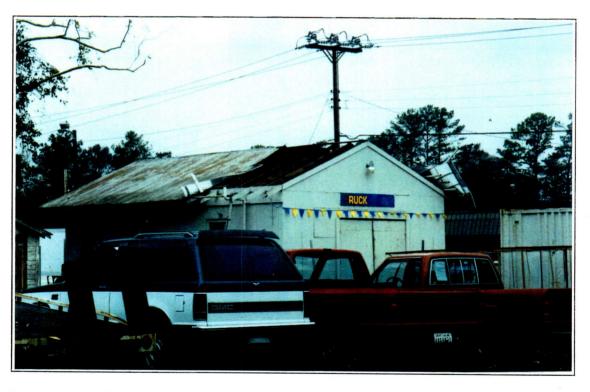
Figure 4-12 Metal roof rolled back by wind.

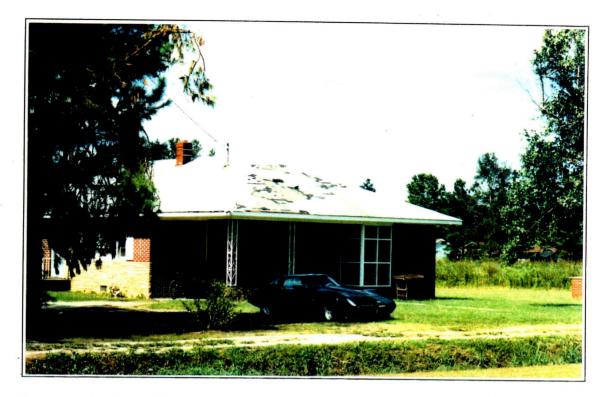
Figure 4-13 Loss of shingles on hip roof.

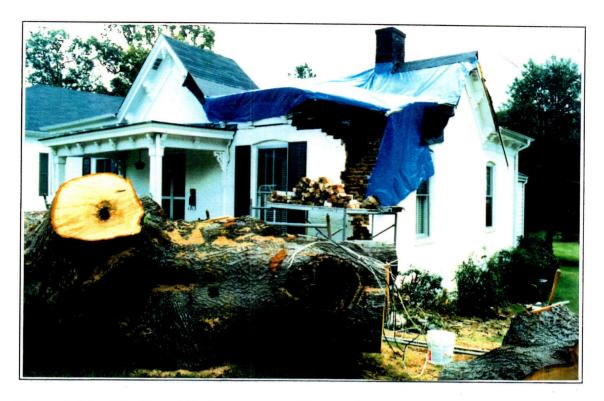
Trees caused collateral damage along the entire path of the storm as far north as South Boston, Virginia. Figure 4-14 represents tree-caused structural damage in South Boston, Virginia. Sustained wind speeds in Raleigh reached 54 mph. In Danville (near South Boston and Martinsville), the sustained speed was 50 mph. The peak gusts in both locations were between 40 percent and 50 percent higher than sustained winds, again indicating the presence of convective activity and severe thunderstorms.

Figure 4-14 Significant damage caused by wind-downed trees.

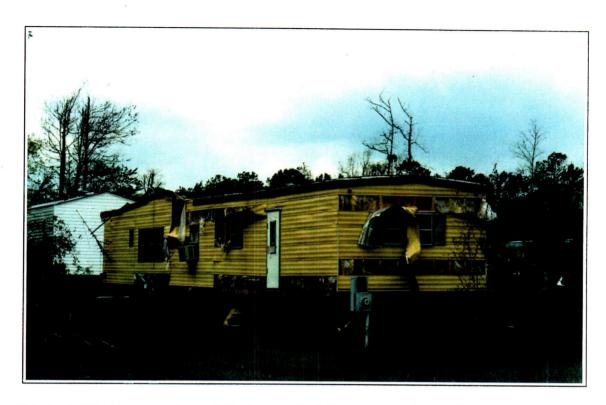
Damage to mobile homes in inland areas generally was limited to cladding and roof coverings, as illustrated in Figure 4-16. This home is located a few miles inland of Surf City, North Carolina, and probably experienced sustained winds of less than 90 mph. The sustained wind speed west of Wilmington, North Carolina, was probably less than 70 to 80 mph. At this speed, the wind was able to overturn the unanchored mobile home shown in Figure 4-17. Near Wilson, North Carolina, the wind reached a sustained speed of approximately 50 mph and pulled several sheets of roof sheathing off a mobile home. In addition, there were many instances of trees falling onto mobile homes and causing significant damage.

Figure 4-16 Damage to mobile home cladding and roof coverings.

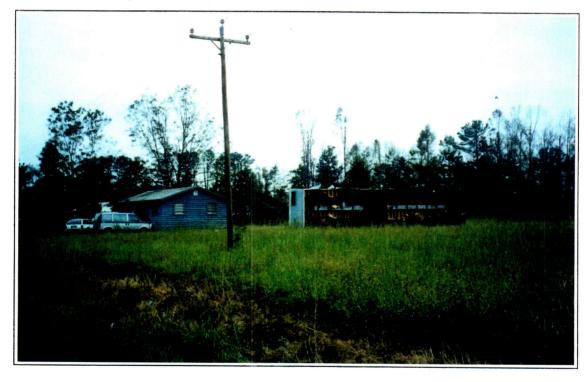
Figure 4-17 Mobile home overturned by wind.

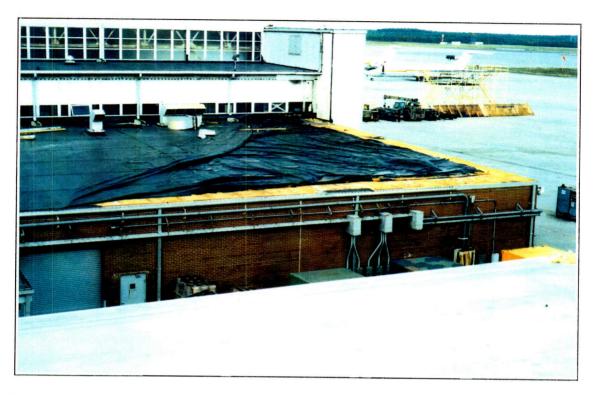
Figure 4-20 Damage to airport hangar roof at Cherry Point, North Carolina.

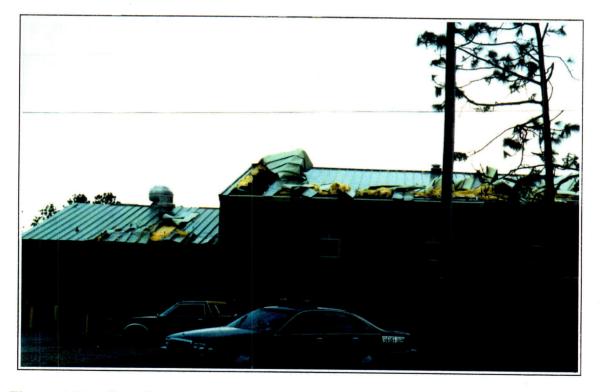
Figure 4-21 Standing-seam metal roof peeled back from roof joist system by wind.

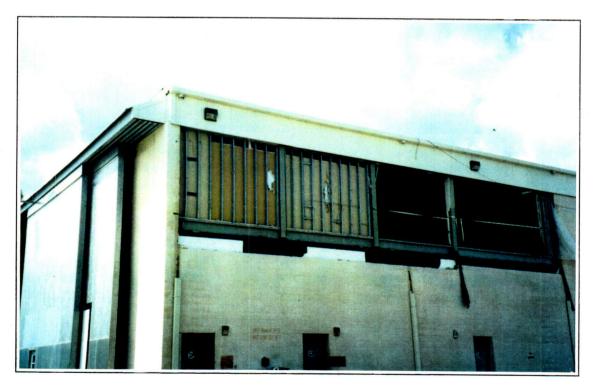
In taller buildings near the coast, such as the airport buildings at New River Marine Air Station, cladding failures did occur. Figure 4-22 illustrates the failure of a 4-inch-thick masonry exterior wall that was pulled away from the steel supporting structure. At Cherry Point, standing-seam metal siding was pulled off a hanger building. A single-ply roof membrane failure occurred as far north as Lynchburg, Virginia. This failure appears to be due to a lack of attachment of the membrane to the sheathing, as shown in Figure 4-23.

Figure 4-22 Masonry wall pulled away from steel supporting structure on airport building at New River Marine Air Station, North Carolina.

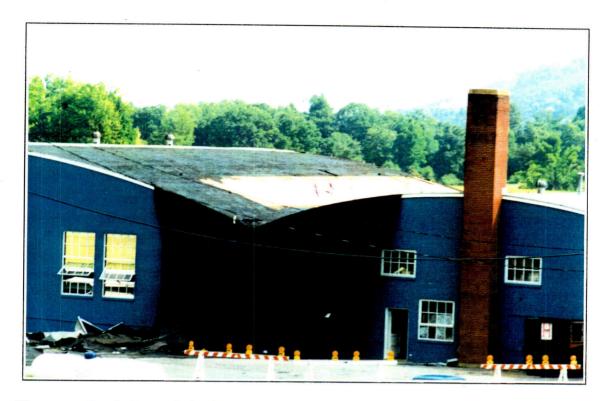
Figure 4-23 Failure of single-ply roof membrane on building in Lynchburg, Virginia.

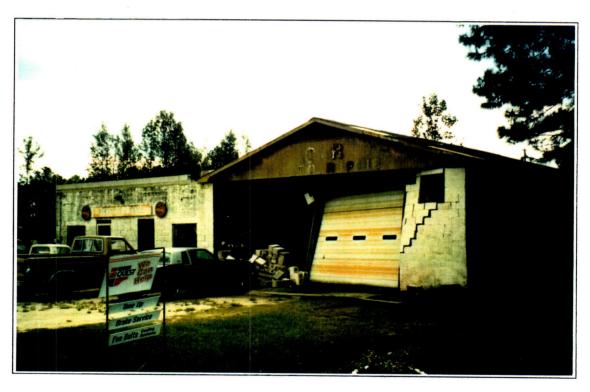
Figure 4-24 shows an 8-inch-thick masonry wall that was imploded by the wind. The damaged building in this figure, located north of Goldsboro, North Carolina, faced due east, where the terrain was primarily open, and was in an area of significant convective activity where sustained winds reached approximately 70 mph and gusts of almost 90 mph were recorded. It appears the wind pushed on the two garage doors in the front wall of the building until the door jambs began to break the masonry on either side. There is no header across the door opening and no apparent structural center support between the doors. This building was clearly built before the Code went into effect; however it was recently remodeled with a new roof, which was lifted off the building and destroyed.

Figure 4-24 Masonry wall imploded by wind.

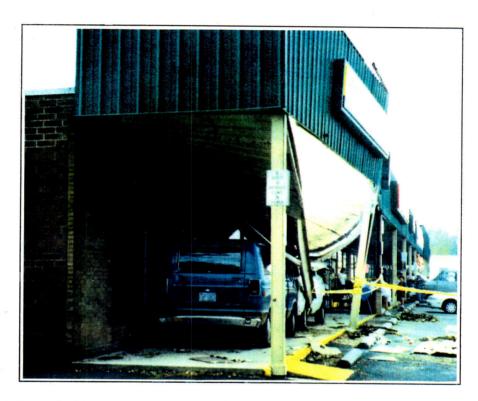
Two structural failures were observed in Wilmington, North Carolina. An airport accessory structure that appeared to be closed on only three sides was destroyed. The roof of a strip mall building was severely damaged when the wind pushed the front facade away from the building and bent a wood support column. The bending of the column allowed the steel roof framing to drop (see Figure 4-25).

Figure 4-25 Roof damage at strip mall building caused by failure of front facade and support column.

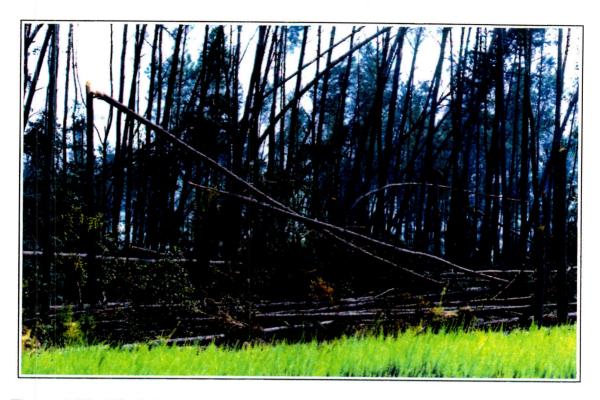
Figure 4-27 Wind damage to pine trees near Raleigh, North Carolina.

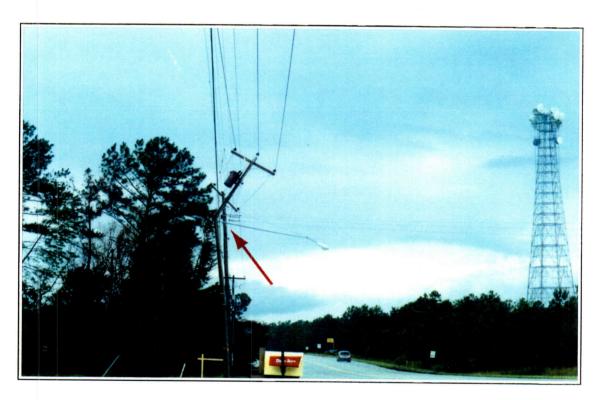
Figure 4-29 illustrates a failure mode for power poles that broke at the point where a heavy load (such as a light) was attached. The loss of power affects many types of operations in addition to the residential customer. For example, a liquefied propane gas operator had to shut down his operation and burn off the propane already produced, because electricity is needed continuously to cool the propane and prevent it from creating hazardous conditions in the pipelines. Also, many water and wastewater treatment plants do not have the backup power they need to remain in operation.

Figure 4-29 Failure of power pole at point of load attachment.
